Assessment of Dam Safety of Coal Combustion Surface Impoundments

Coletto LP, LLC

Coletto Creek Power, LP

March 11, 2011

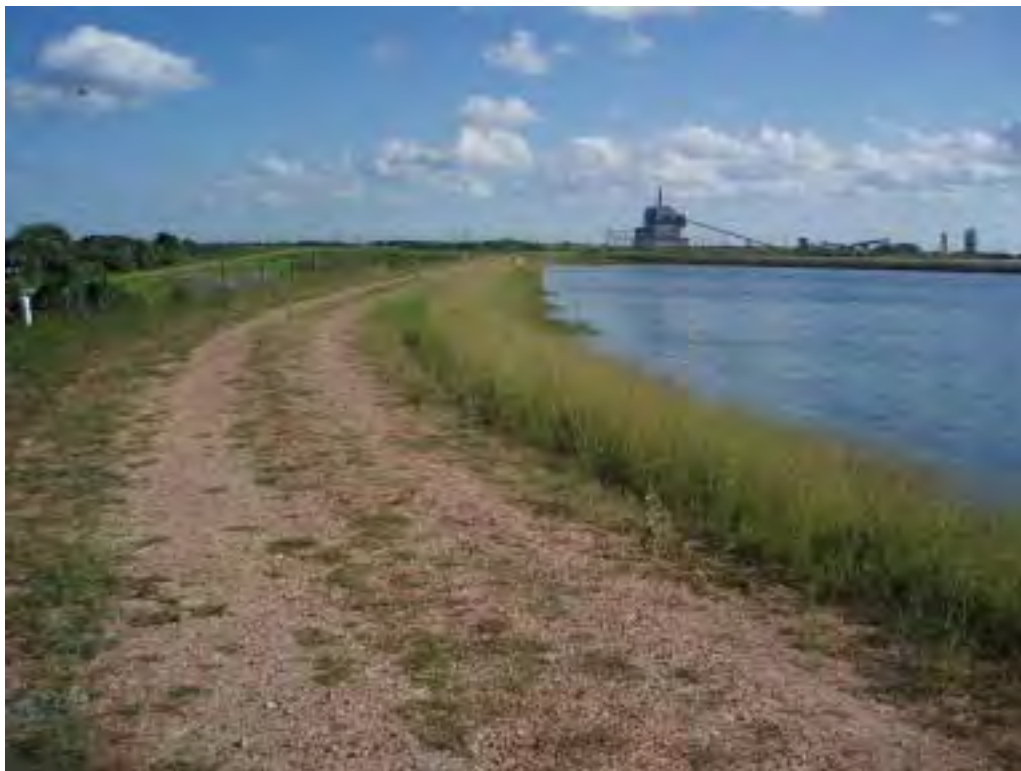
The crest of the Secondary Pond embankments appeared to be generally in fair condition (Photos 2, 14, 17, 41, 46, and 47). The crest was generally approximately 20 feet wide. The crest is surfaced with compacted gravel and is used as an access road. Sparse vegetation was growing in the middle and on both sides of the roadway. A barbed wire fence used to contain livestock was observed on the north and east embankment crest perimeter (Photos 46, 47, and 48). The vertical alignment of the fence posts was in good condition. Observed freeboard at the time of the visit was approximately three feet.

Photo No. 47: Secondary Pond - East embankment interior slope and crest, looking south.

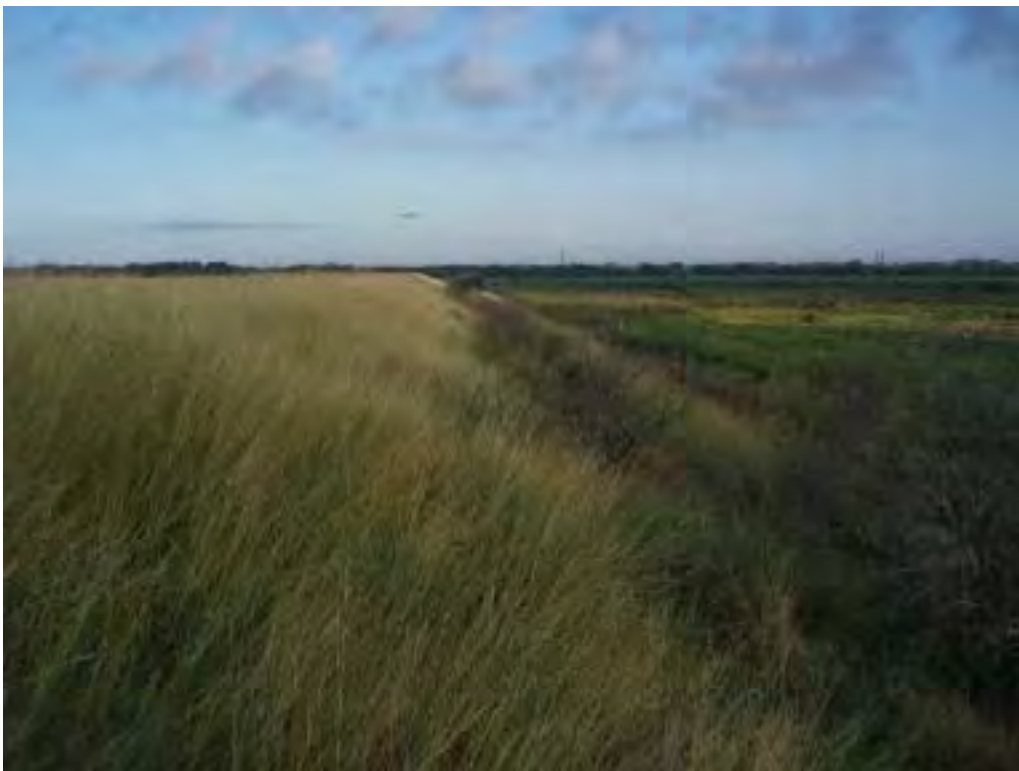
The exterior slopes appear to be in fair condition. The exterior slopes on the north, southern, west, and east embankments were approximately 2.5H:1V (Photos 49, 52, 53, 56, 62, 66, 67, 72, 76, 79, 82, 86, 90, 91, 96, 99, 104, 111, and 114). The northeast slope of the divider embankment between the Primary Ash Pond and Secondary Pond was approximately 3H: 1V (Photos 1 and 15).

Photo No. 49: Primary Ash Pond - North embankment exterior slope, looking west. Note 8- to 12-inch-diameter mesquite trees on slope.

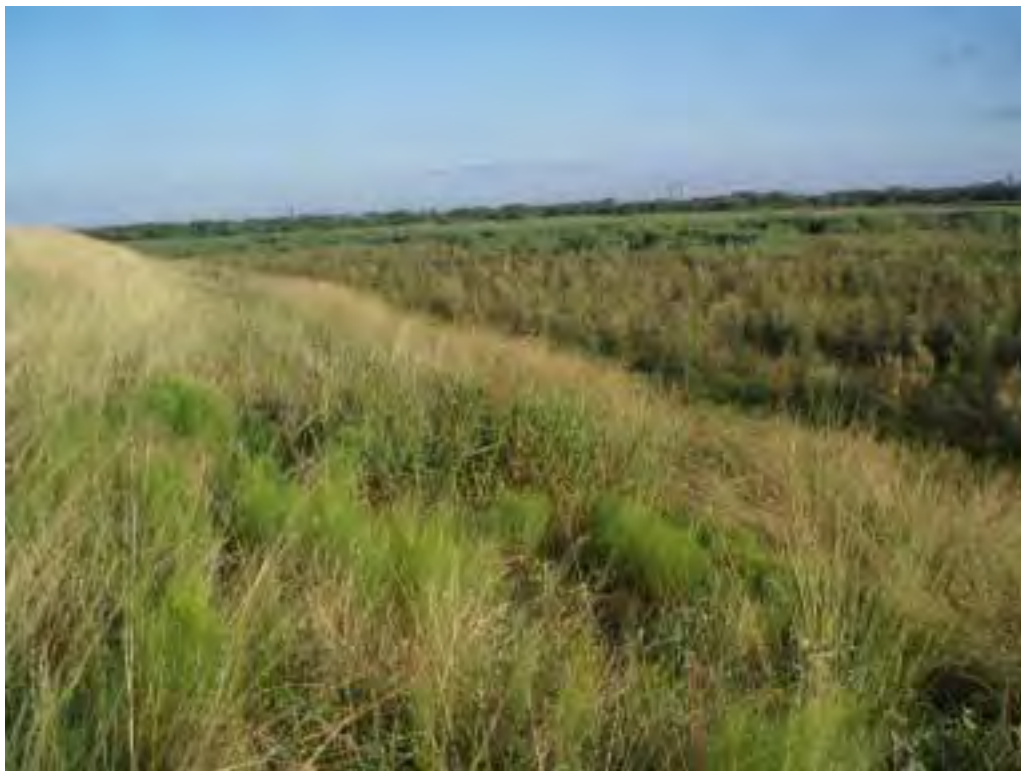
Photo No. 53: Primary Ash Pond - North embankment exterior slope, looking west at lush vegetation.

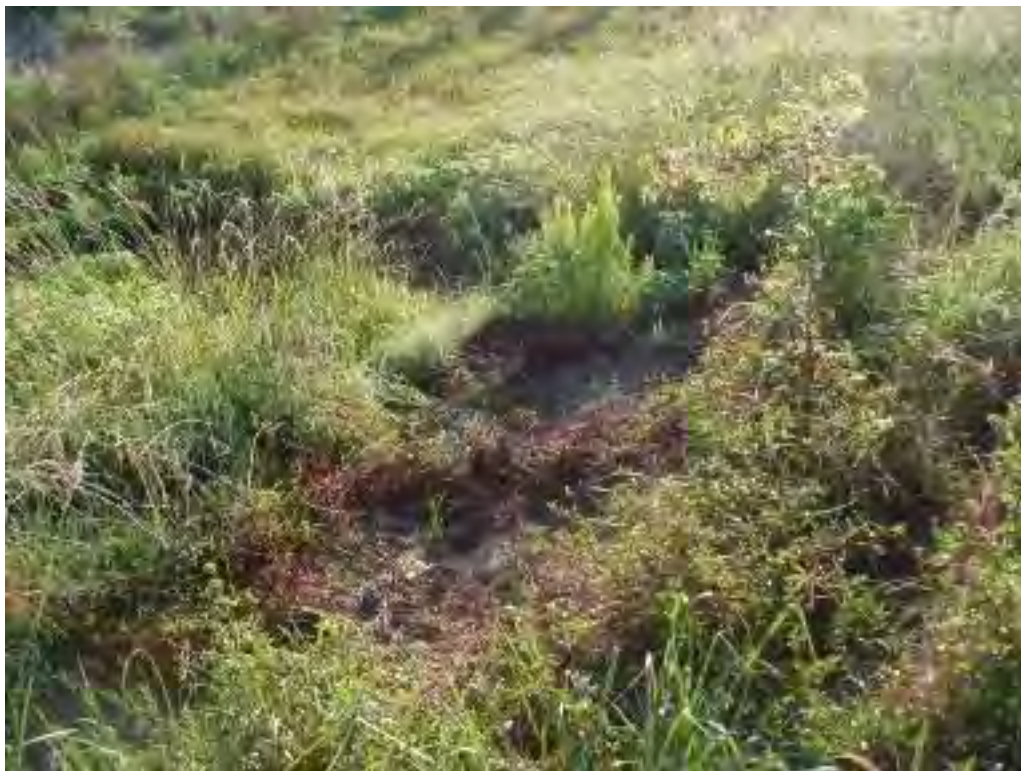
On the north embankment there was some minor surface erosion near the toe adjacent to the evaporation pond (Photo 55). Water was observed adjacent to the west embankment toe in the evaporation pond (Photos 67 and 69).

Photo No. 55: Primary Ash Pond – North embankment exterior slope, looking at surface erosion area.

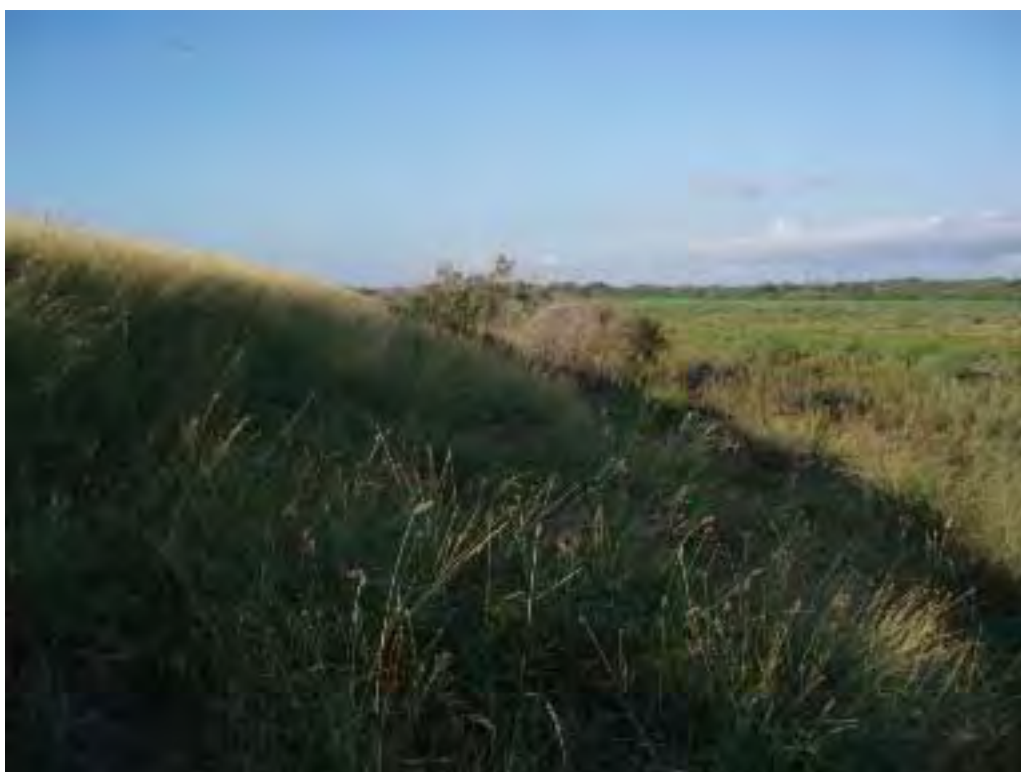
The north, west, and east embankments were generally covered with grass and small brush approximately 24 to 48 inches tall. On the north and west embankments there were 6- to 12-inch-diameter mesquite trees on the slope (Photos 52, 62, and 66). Smaller mesquite trees, 1 to 2 inch inches in diameter were observed on the east embankment. On the north embankment, areas of well-established vegetation were observed (Photo 53). The southwest, south, and southeast embankments were covered with grass approximately 6 to 12 inches tall.

Photo No. 62: Primary Ash Pond - West embankment exterior slope, looking south.

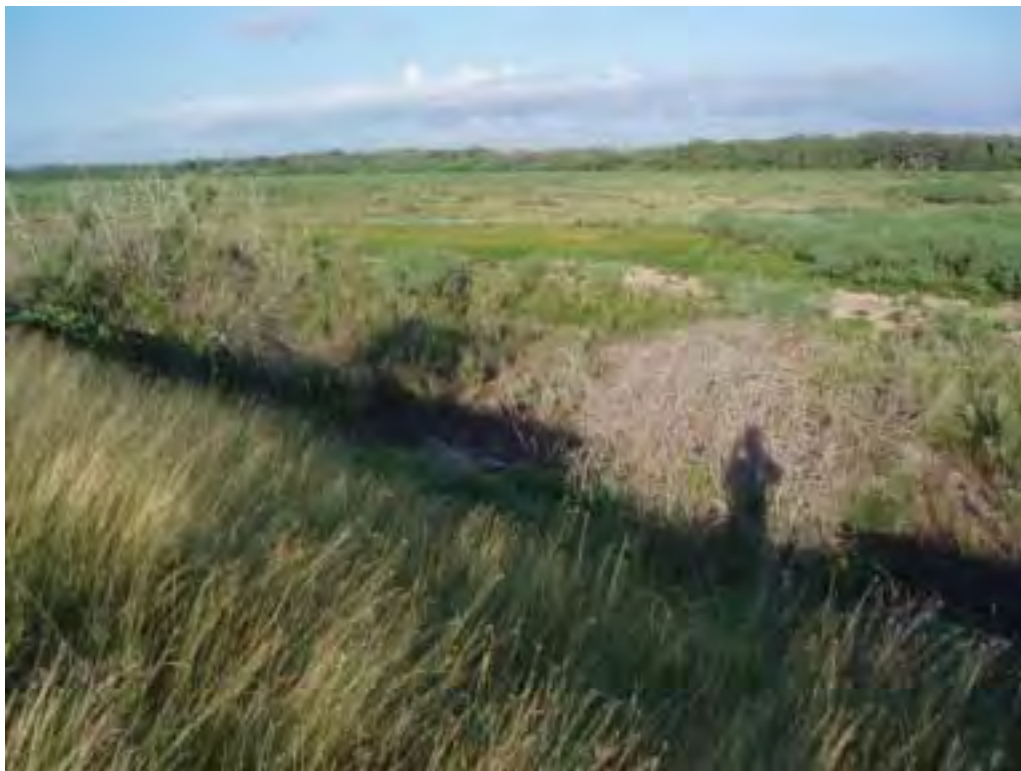
Photo No. 65: Primary Ash Pond - West embankment exterior slope, looking southwest at bare spot at toe and two mesquite trees. Tree diameters range from 6 to 12 inches.

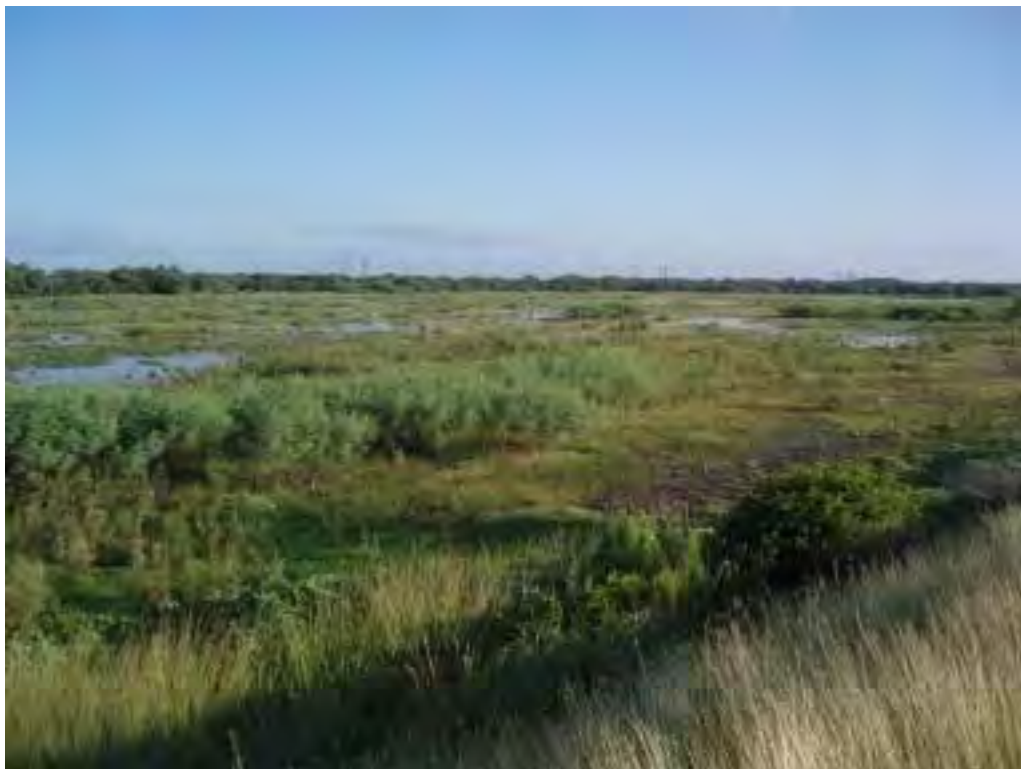
Photo No. 67: Primary Ash Pond – West embankment, looking northwest at Evaporation Pond.

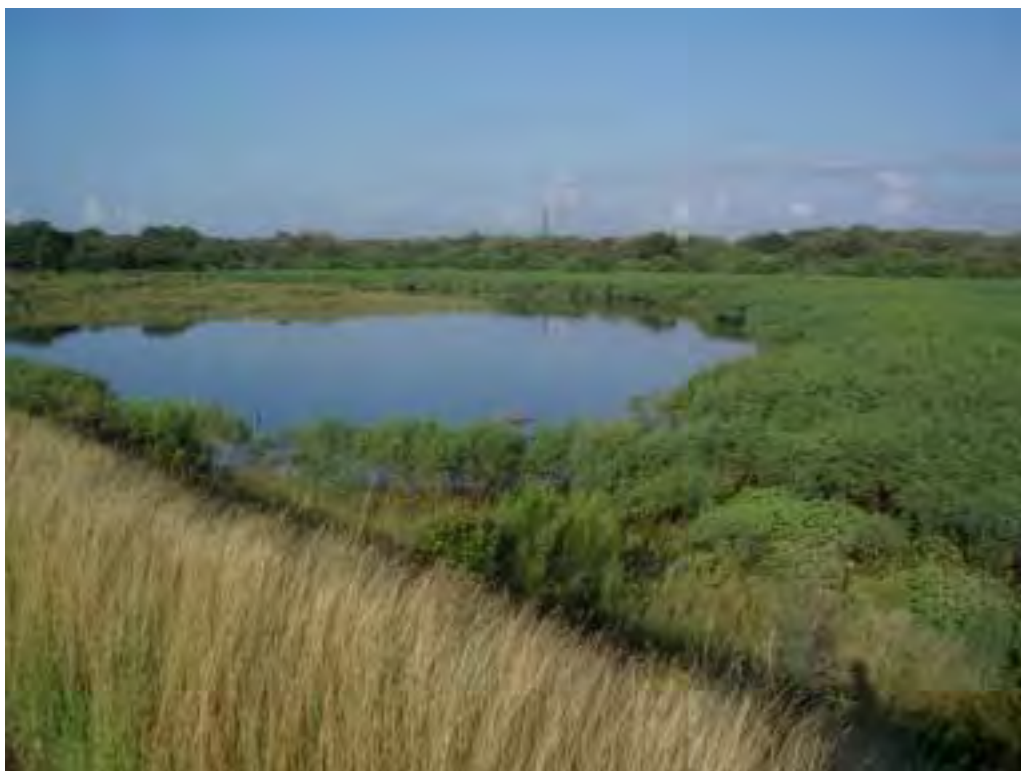
Photo No. 69: Primary Ash Pond – West embankment, looking southwest at Evaporation Pond.

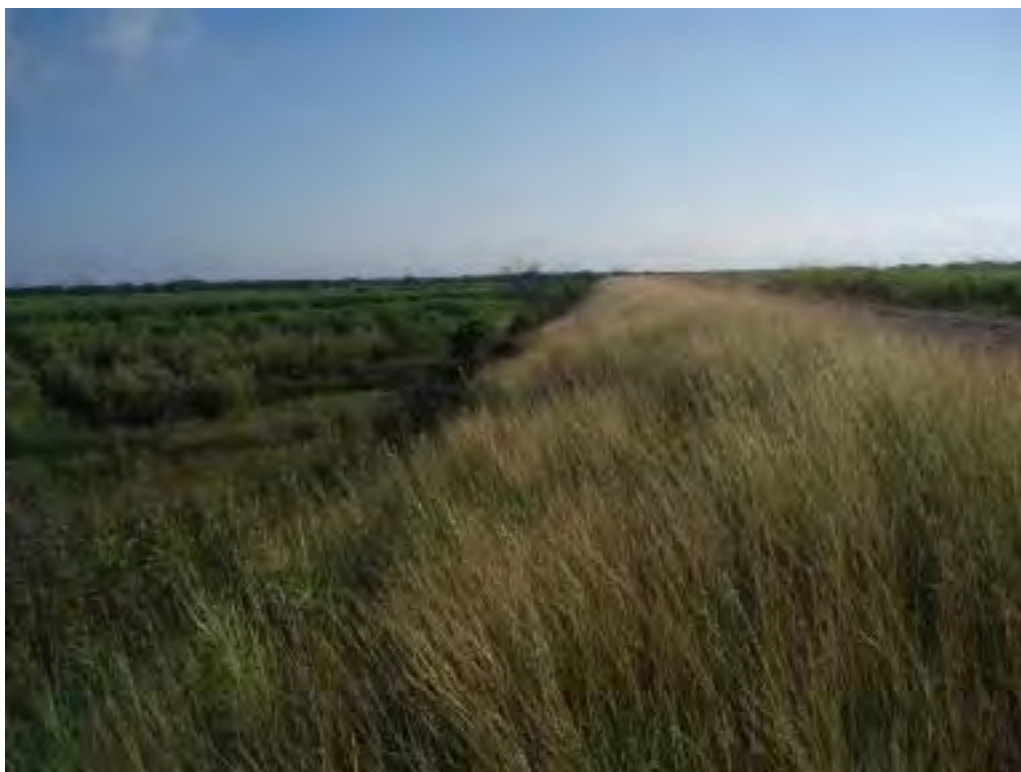
Photo No. 72: Primary Ash Pond – West embankment exterior slope, looking northeast.

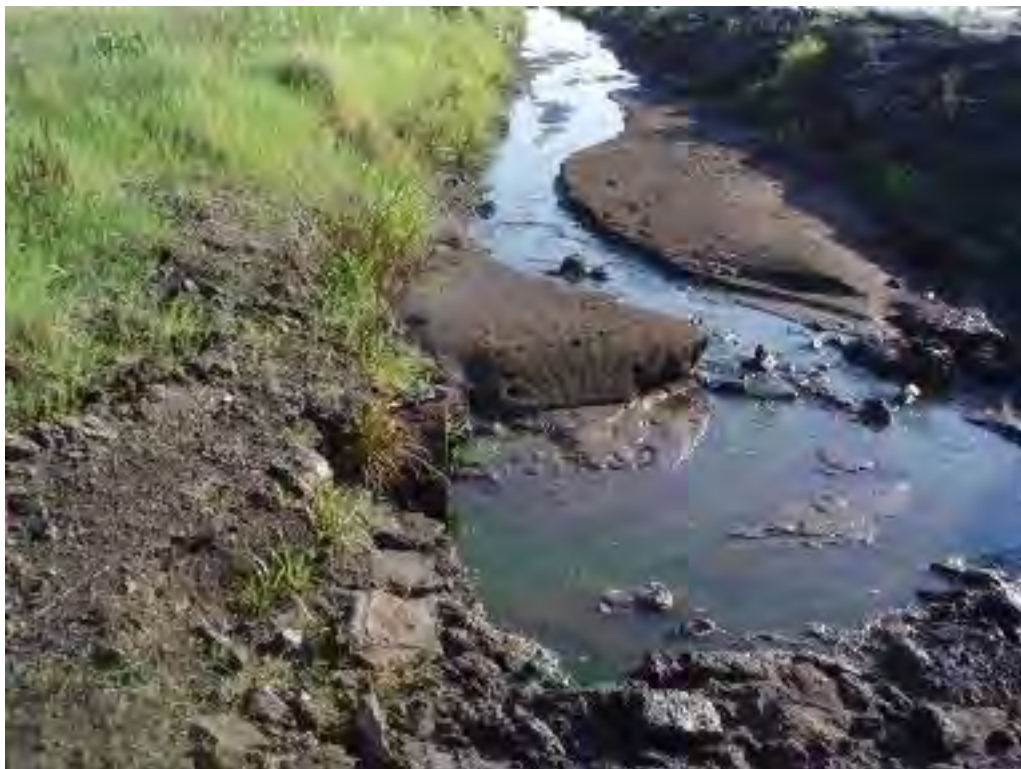
During the site visit, four sets of sluice pipes were observed. The two CCW sluice pipes on the southeast and south embankment appeared to be in fair condition (Photos 80, 81, 83, and 84). The boiler area sump sluice pipe on the west embankment and the demineralizer effluent sluice pipe on the southeast embankment also appeared to be in fair condition (Photos 75 and 85). No seepage was observed where the pipes penetrated through the embankment.

Photo No. 75: Primary Ash Pond - West embankment interior slope, looking at 20-inch-diameter DI surface water decant pipe.

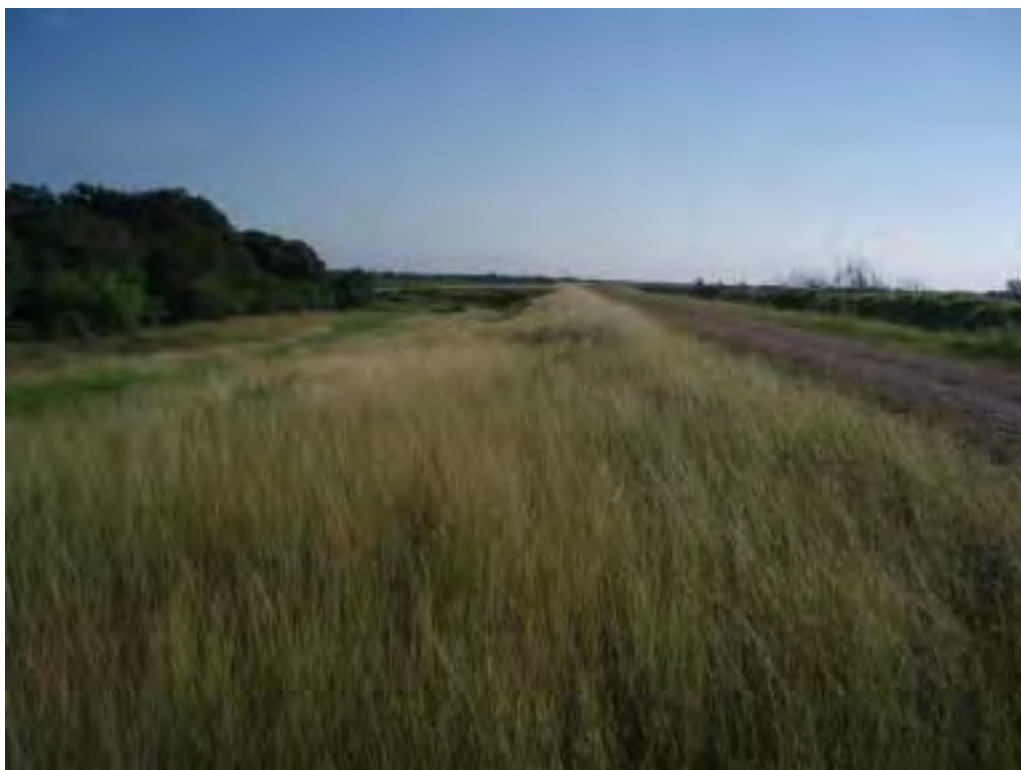
Photo No. 76: Primary Ash Pond - West embankment exterior slope, looking northeast.

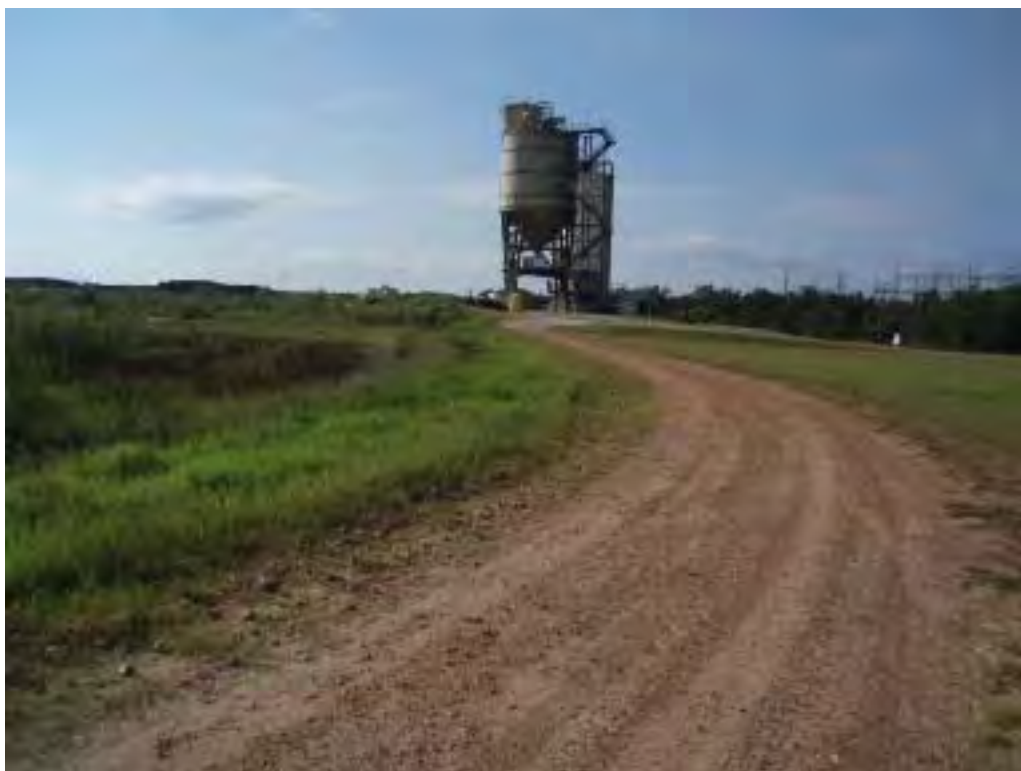
Photo No. 79: Primary Ash Pond – Southwest embankment crest and exterior slope, looking southeast toward Boral Materials Technologies' fly ash silos.

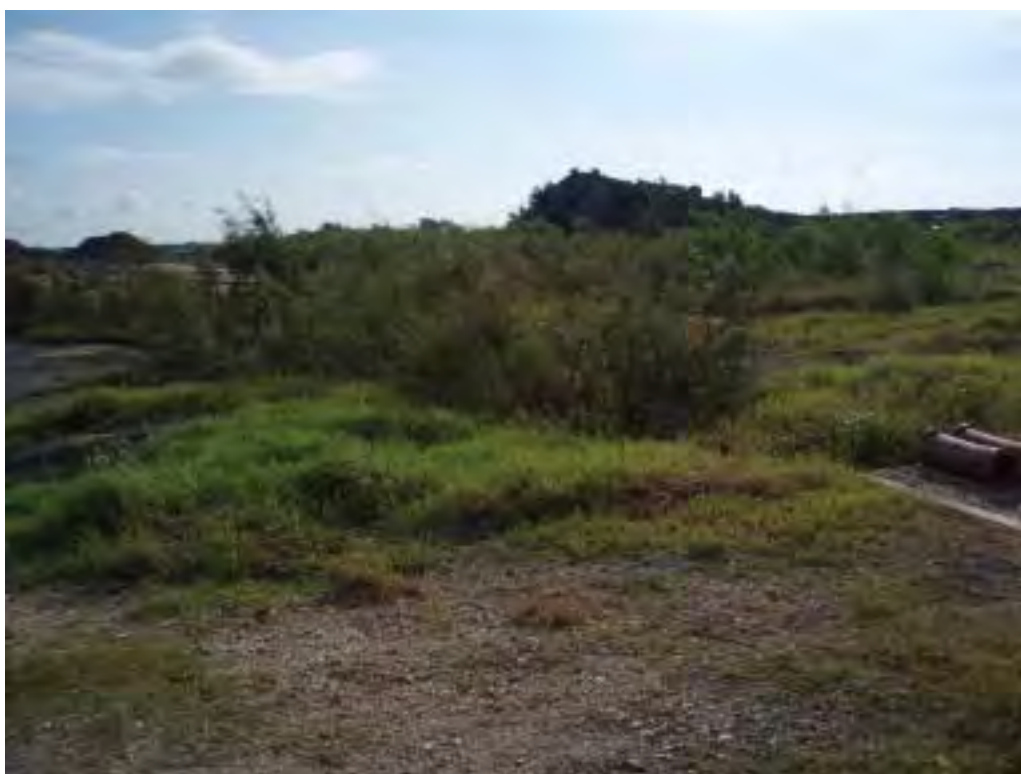
Photo No. 80: Primary Ash Pond – Southwest embankment, looking northeast at fly ash silo sluice area.

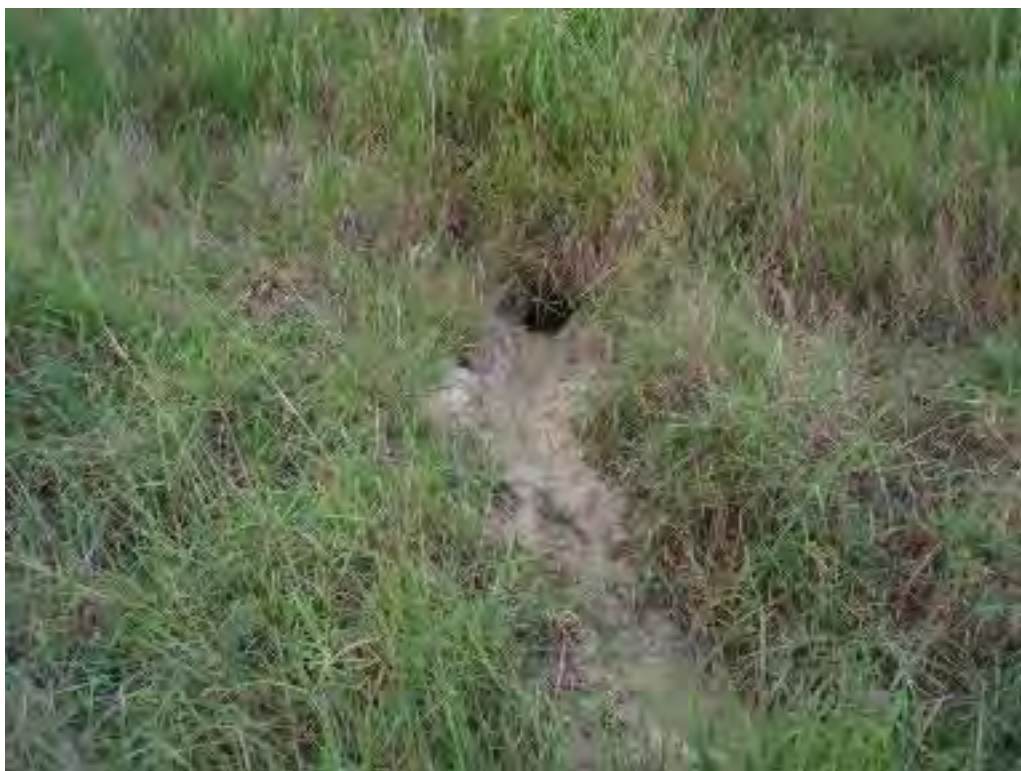
On the southeast embankment two seeps were observed. One of the seeps appeared to have developed at the location of an 8-inch-diameter animal burrow (Photo 97). The other seep observed on the southeast embankment was near the toe of the slope and was approximately 8-feet-long by 2-feet-wide (Photo 98). Flow from the seeps was visually estimated to be averaging less than 10 gallons per day (gpd).

Photo No. 97: Primary Ash Pond – Southeast embankment exterior slope, looking at 8-inch-diameter rodent burrow hole and seep.

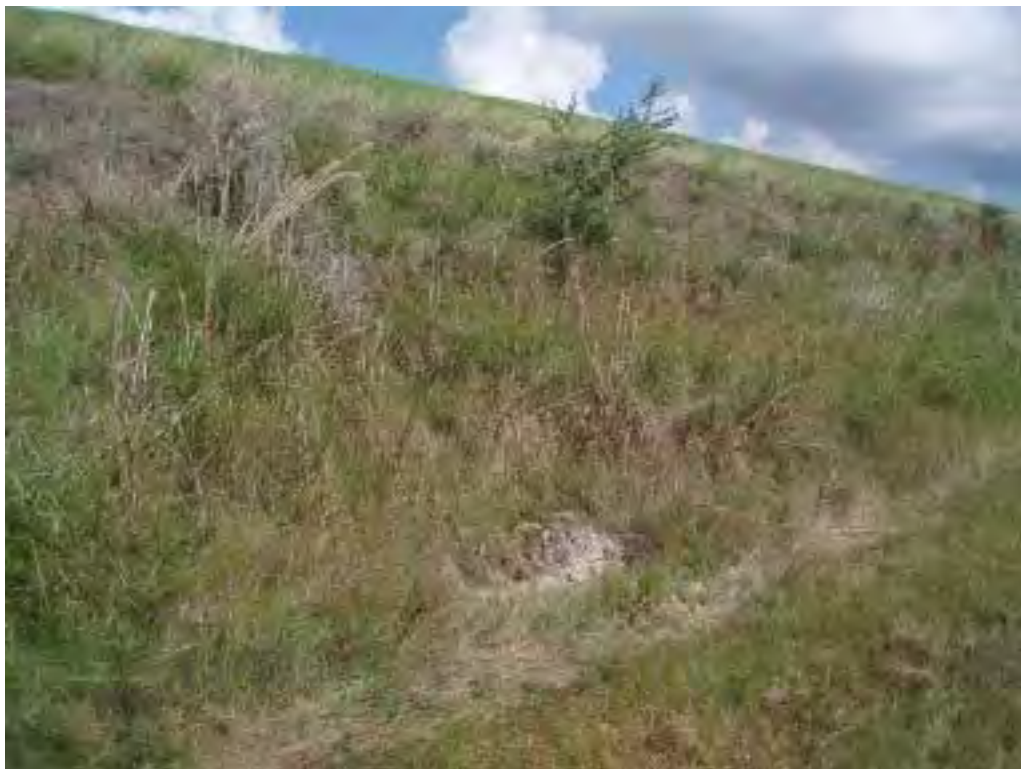
There were multiple seeps observed on the east embankment exterior face and in the toe area. An approximately 40-foot-long by 10-foot-wide seep was observed on the lower third of the slope (Photo 105). To the north of that seep there were more minor seeps that were less than 2-feet-wide and observed near the toe of the slope. These seeps appeared dry and crusted at the time of the site visit. A surface depression approximately 4 feet long by 4 feet wide by 2 feet deep was also observed in the area (Photo 106) of these seeps. A large seepage area approximately 400 feet long by 20 feet wide was observed at the embankment toe area (Photos 107 and 108). The seepage area was saturated, soft, and boggy with standing water up to 12 inches in depth. Well established vegetation, mesquite trees, and hog wallows were also observed in this seepage area. Seepage rates could not be visually estimated in the area of this large seep due to its extent.

Photo No. 105: Primary Ash Pond - East embankment exterior slope, looking northwest at 40'Lx10'W seep on lower third of the slope.

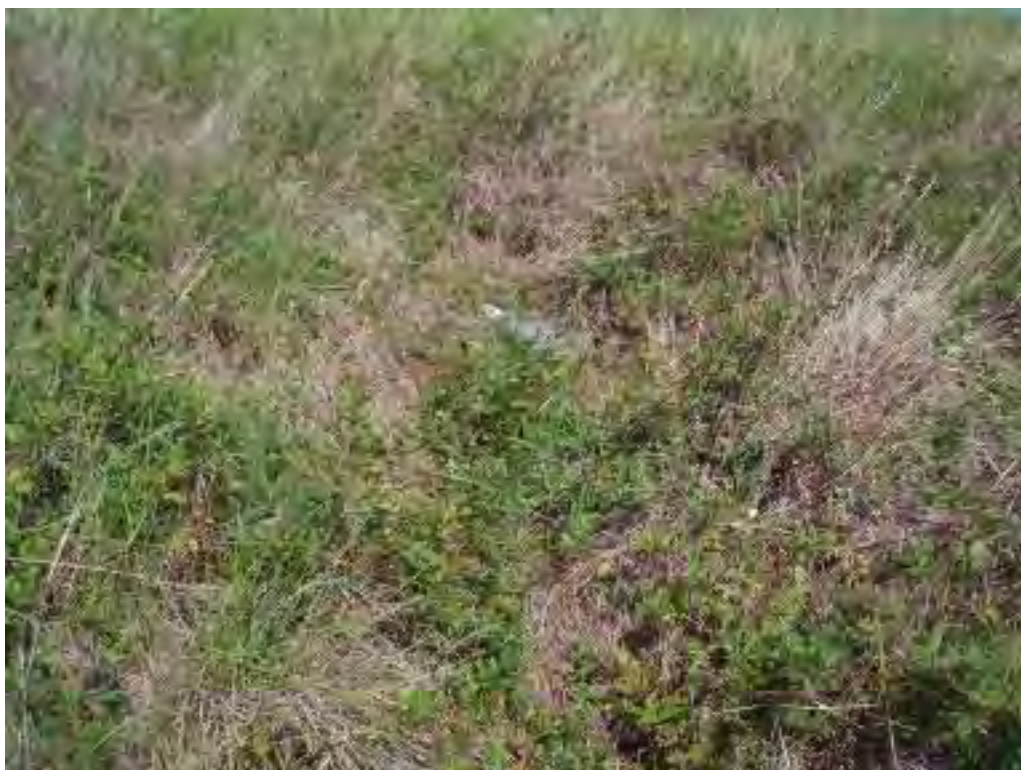
Photo No. 106: Primary Ash Pond - East embankment exterior slope, looking at 4'Wx4'Lx2'D depression. Note apparent dried seepage areas in the vicinity.

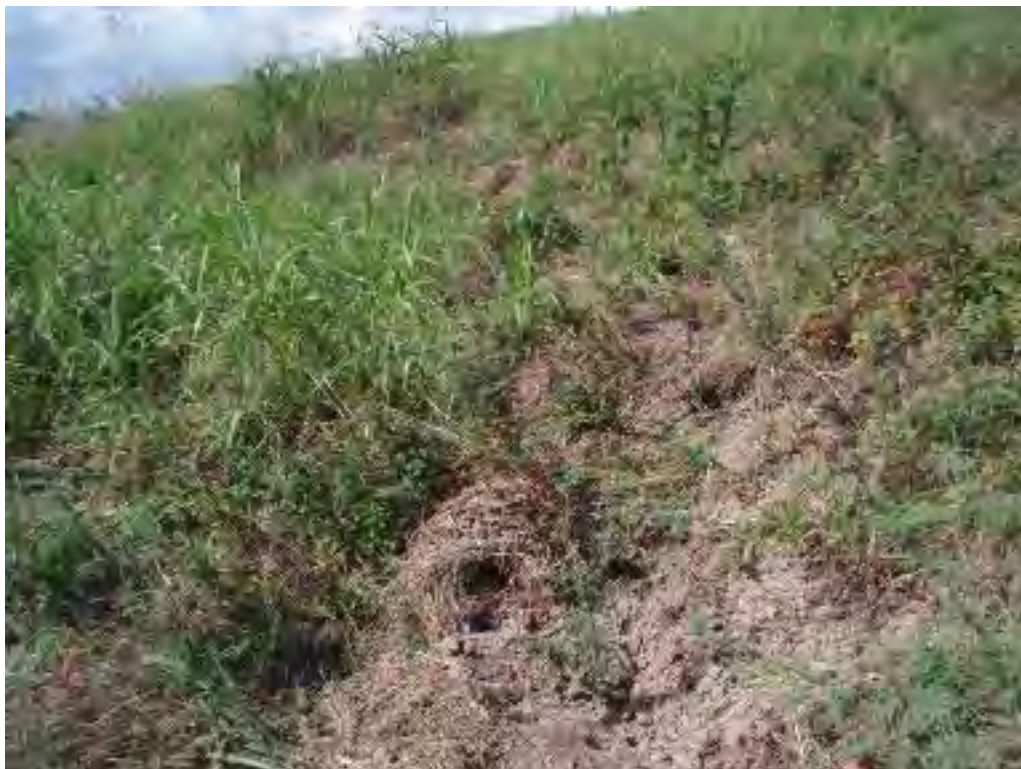
Photo No. 109: Primary Ash Pond - East embankment exterior slope, looking at an area disturbed by animal activity.
